ONTARIO THRUWAY  
MONTEZUMA SWAMP  
SPOIL BANK SLIDE  
CLYDE RIVER RELOCATION

CATSKILL THRUWAY  
DELAWARE AVENUE SLIDE

EMBANKMENT FOUNDATION PROBLEMS IN SYRACUSE AREA

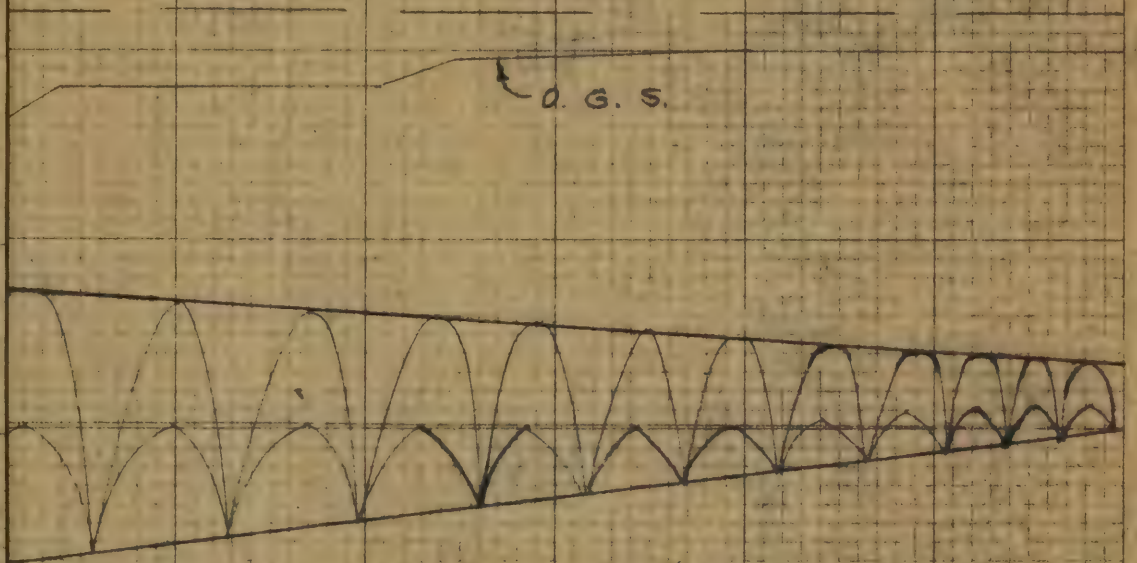
SO. NEW BERLIN SLIDE  
DRAIN SPACING DISCHARGE  
DRAWDOWN

DRAIN S	x	x	x	x	x	x	x	x	x	x	x	x	x	x
DISCHARGE PIEZOMETER AT K = 5 F	.11	.10	.09	.08	.07	.06	.05	.04	.03	.02	.01			
DISCHARGE PIEZOMETER AT K = 5 F	.21	.19	.18	.17	.16	.14	.12	.12	.11	.11	.10	.09		
	00	T 409+00				T 410+00				T 411+00

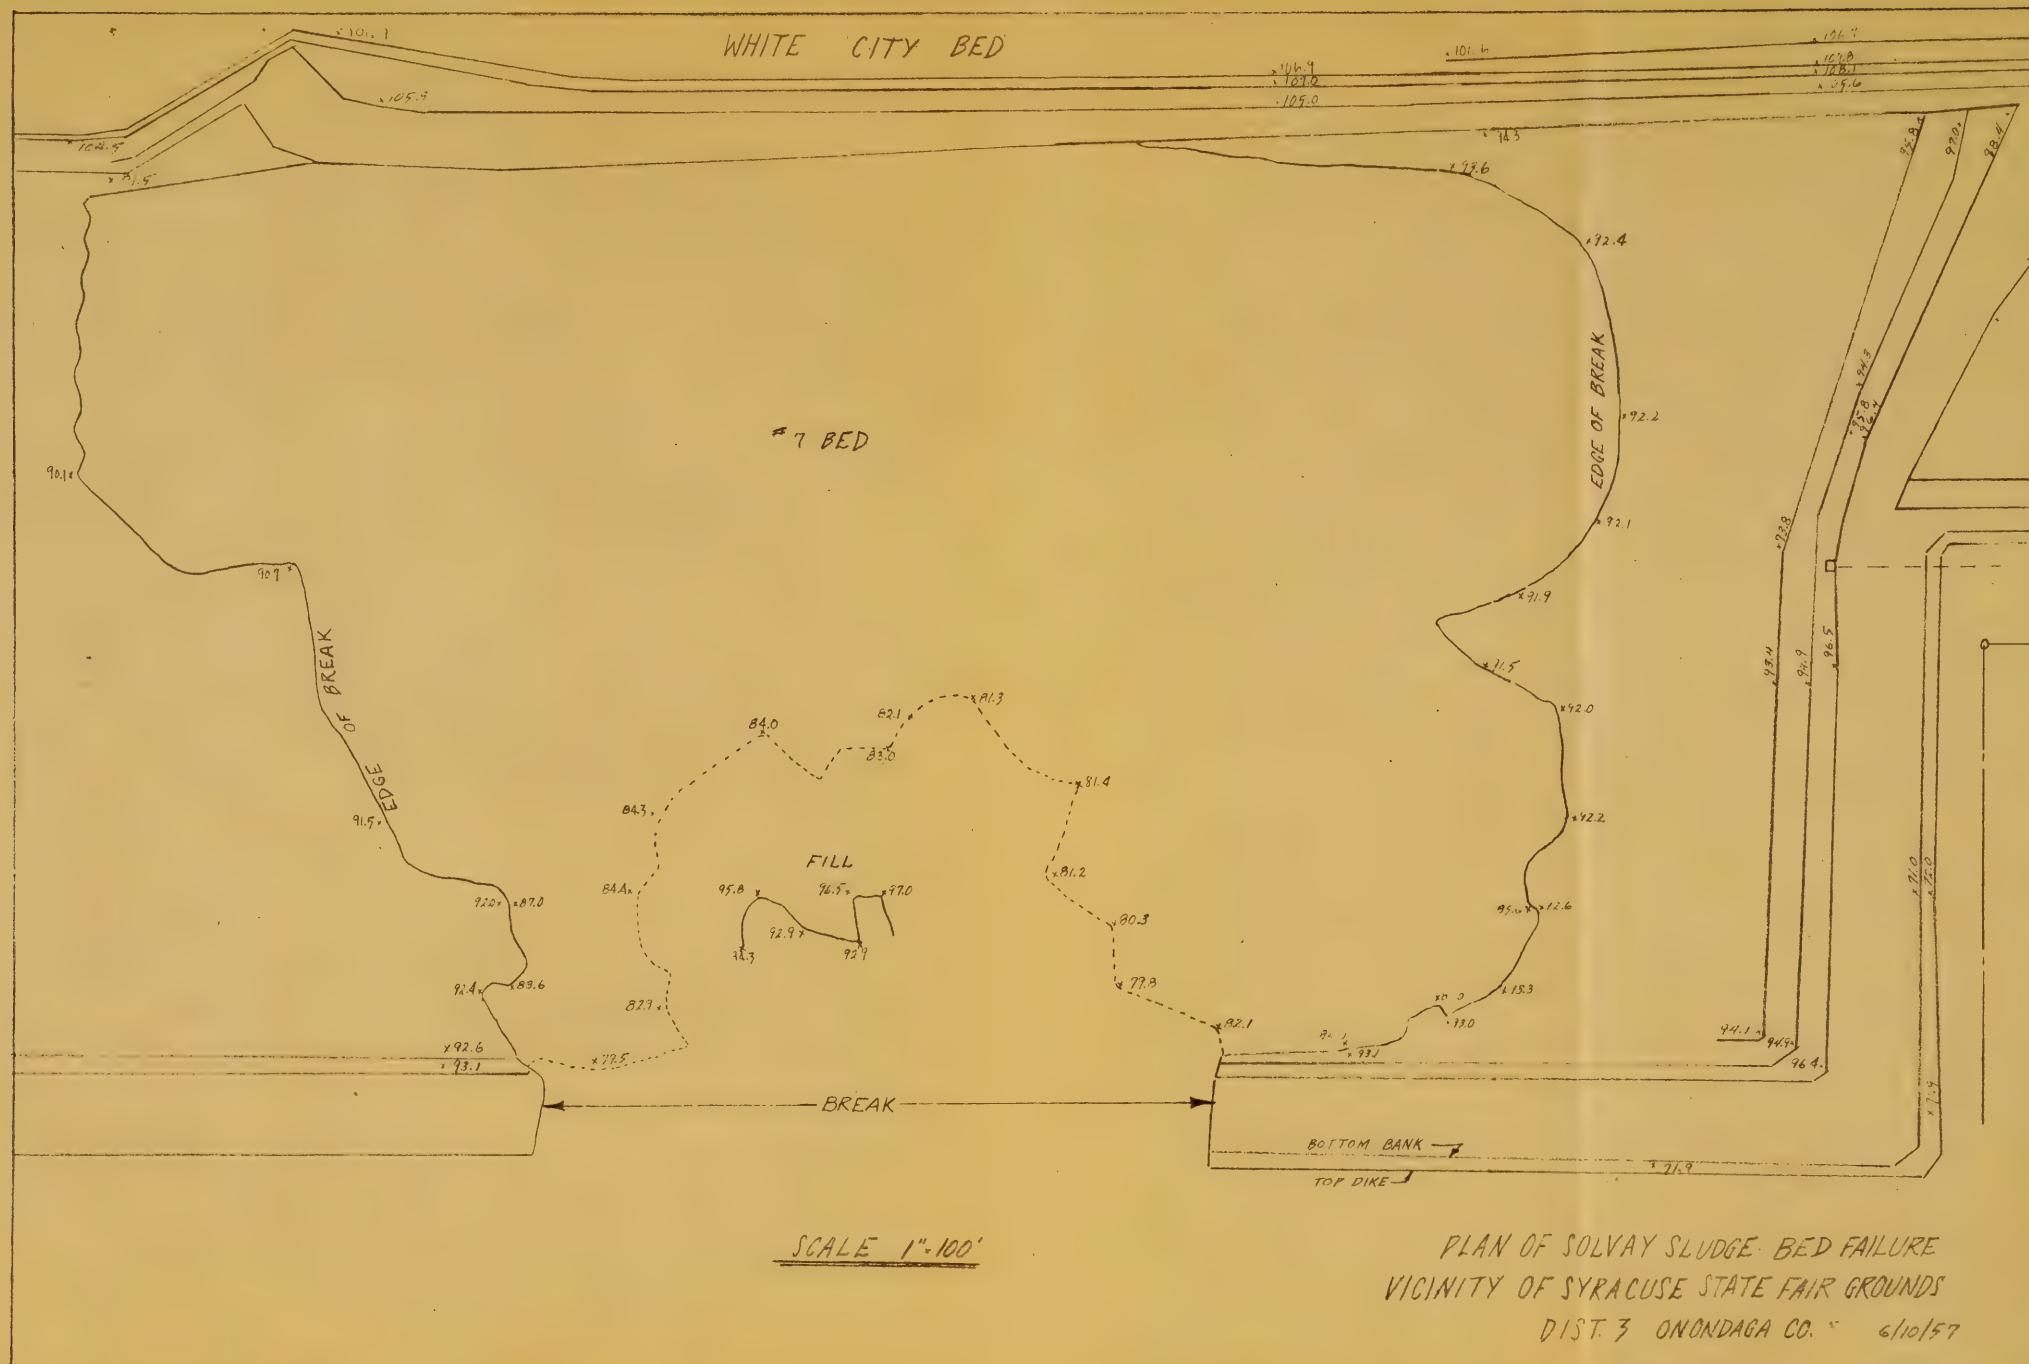
OLVAY SLUDGE BED FAILURE  
YRACUSE STATE FAIR GROUNDS  
ST. 3 ONONDAGA CO. 6/10/57

The design safety factor was 1.25.  $C = 200$  PSF and  $\phi = 25^\circ$  was assumed for the marl layer.  $C = 200$  PSF and  $\phi = 11^\circ$  was assumed for the silt and clay layer. The analysis also considered a full depth tension crack. Triaxial tests showed that the marl developed its full strength at a strain of 8-10% with a resulting drop of strength of approximately 20% at a strain of 5%. The stress-strain curves for the silt and clay were not run out beyond 5% to determine the loss of strength with greater strain.

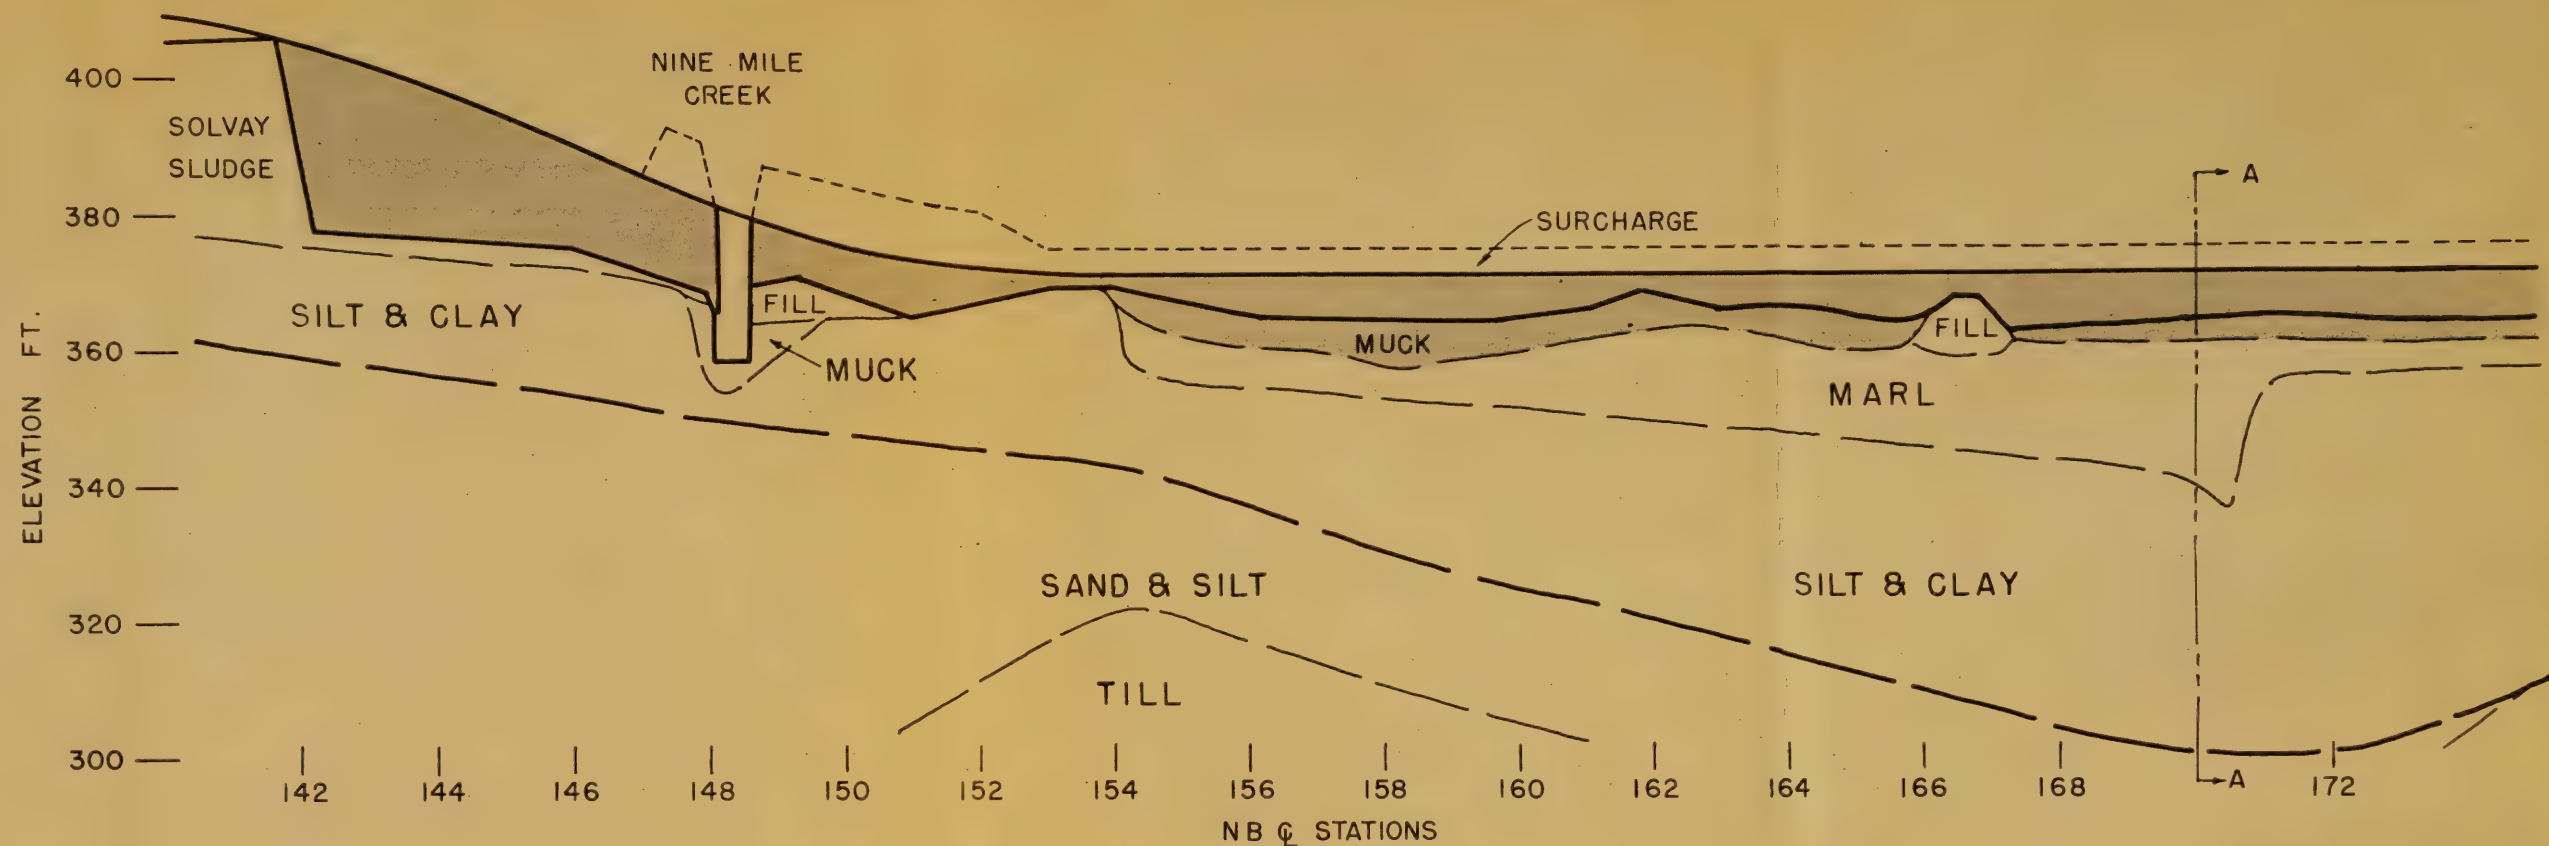
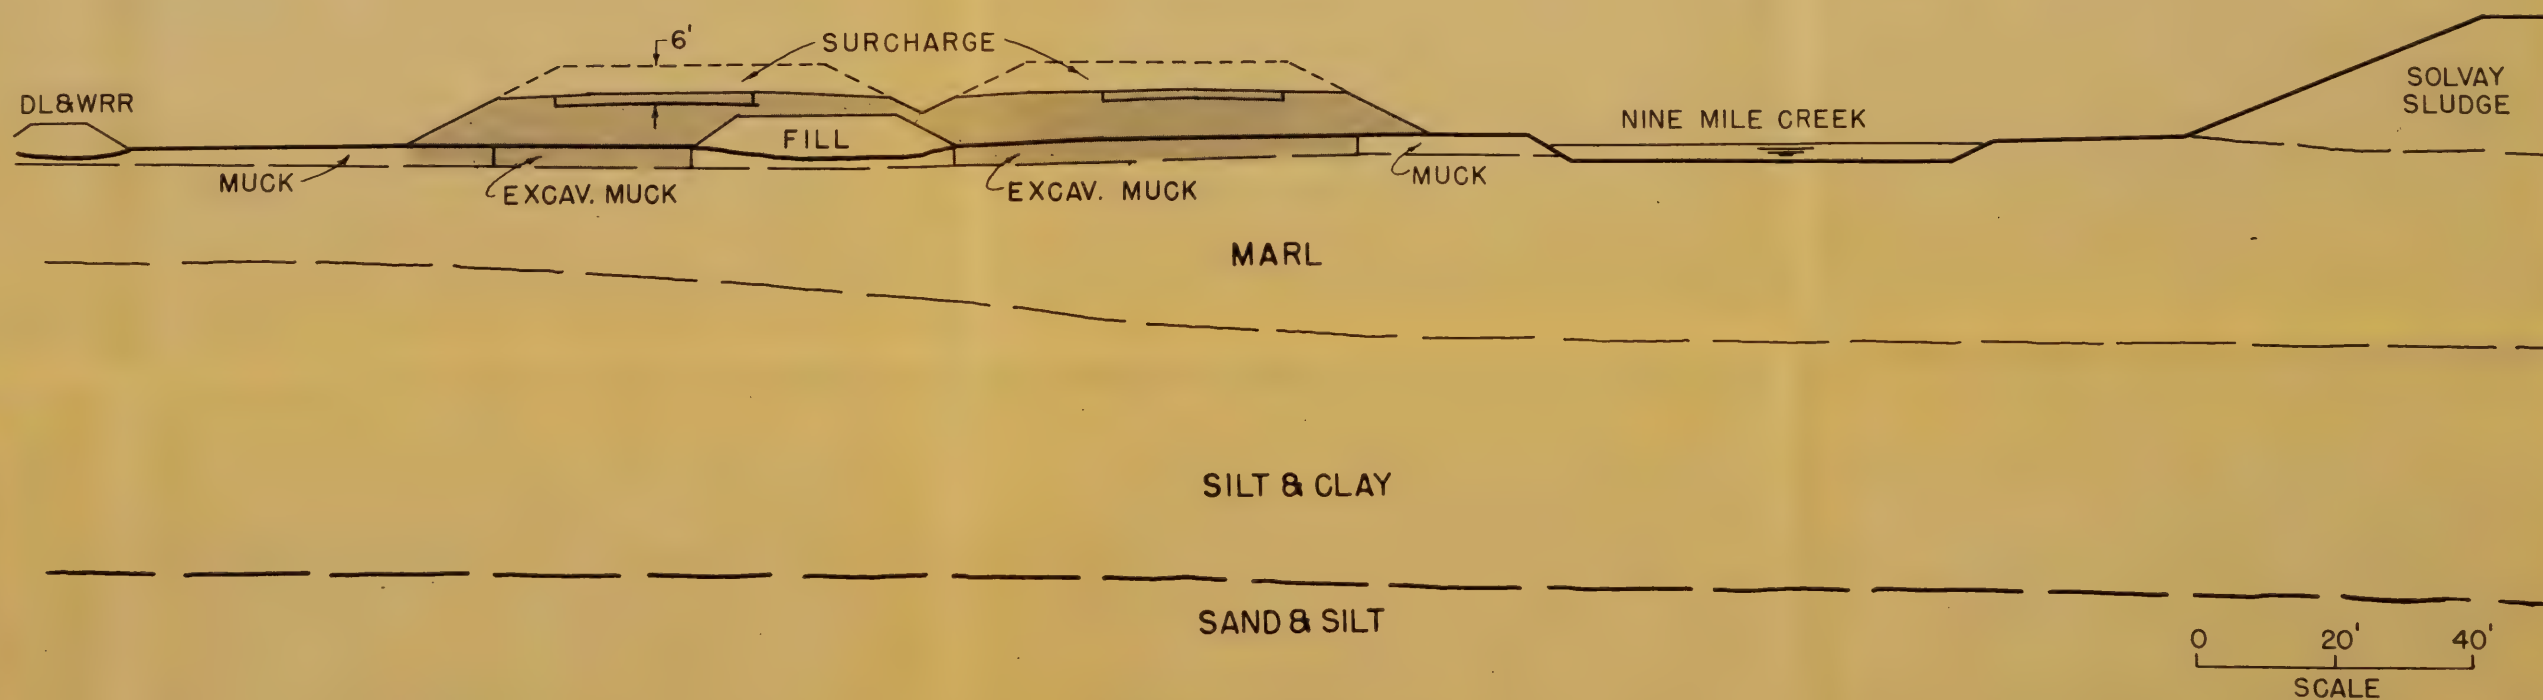
# LAKE ONONDAGA WEST SHORE DEVELOPMENT NORTH OF STATE FAIR GROUNDS

Figure No. 5 shows a profile of the Lake Onondaga West Shore Development north of the sludge beds and the State Fair Grounds. Here, this road takes off from the top of the sludge beds and comes down across Nine-Mile Creek into the flats adjacent to the lake. The foundation consists of sludge, muck, marl, and silt and clay, and occasional man-made fills. During construction, the muck was removed and the fill placed either on the sludge or marl, with a surcharge added to hasten settlement. The worst foundation conditions were at Section A-A. At this location, the marl and silt and clay were deepest, stability was quite critical, and a shear failure was a distinct possibility. As it turned out, a shear failure did occur within the limits of the northbound lane during the placement of surcharge. The conditions were aggravated by the nearness of the creek which here runs parallel to the road. This failure has since been repaired.

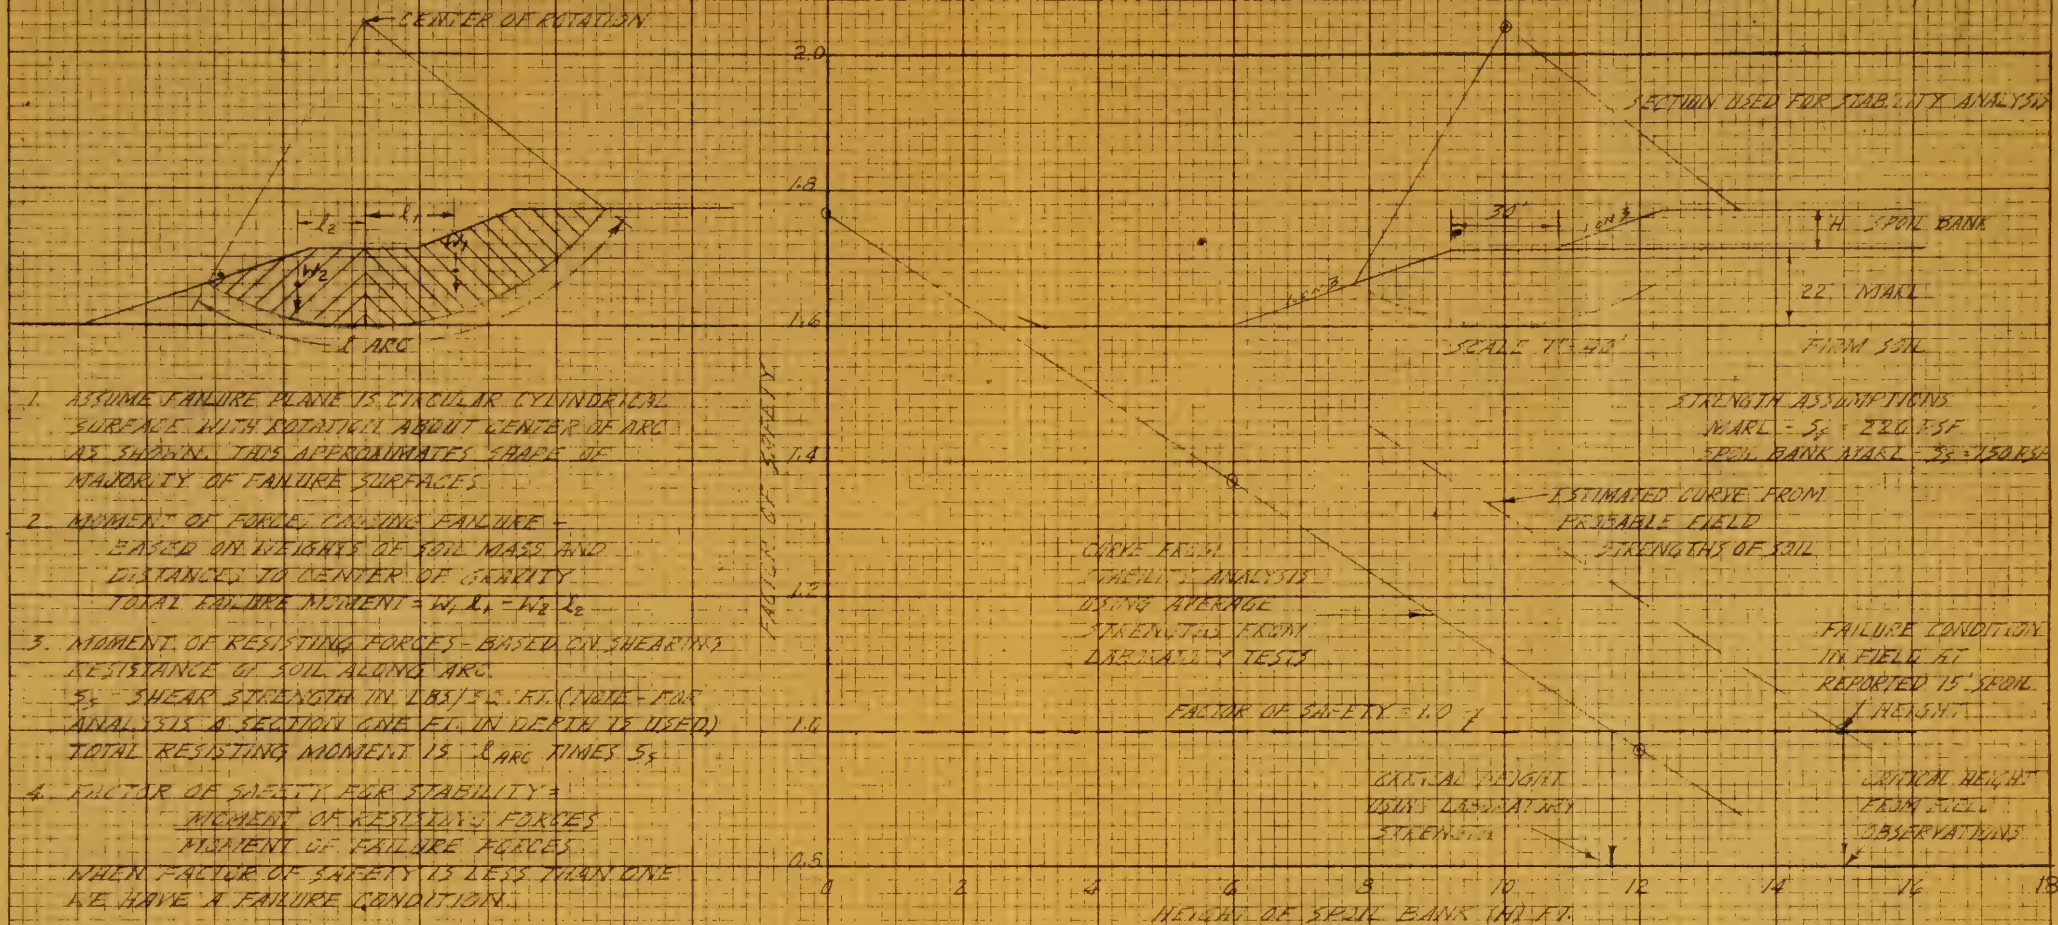
FACTOR OF SAFETY VS. HEIGHT OF SPOIL BANK (H)

FAILURE CONDITION IN FIELD AT REPORTED 15' SPOIL HEIGHT

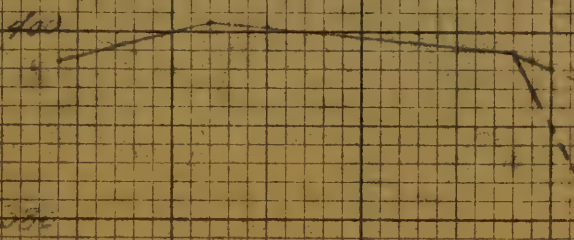
STABILITY ANALYSIS  
SPOIL BANK SLIDE  
CLYDE RIVER RELOCATION  
TYPE-MONTEZUMA CT 51-5

FAILURE CONDITION IN FIELD AT REPORTED 15' SPOIL HEIGHT

CRITICAL HEIGHT FROM FIELD OBSERVATIONS
